Building Number: 32

Original Name: Office/Storage

Building 32, Truro Air Base, North Truro, Massachusetts

Project: Former Air force Station
Location: North Truro, MA

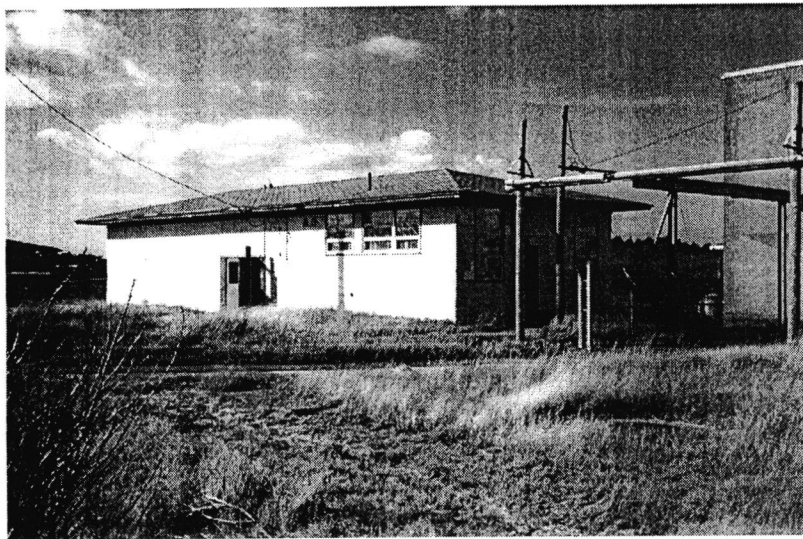
View from southeast.

Low-pitched hipped roof with composition shingles is in **fair/ good condition**. Deep overhangs are in **fair condition**. Recommend repair and repaint soffits.

Wood-frame structure sheathed in cement asbestos shingles is in **fair condition**; replacement of siding required. 6 windows: aluminum three-lite awning type in fair condition. Seals failed; recommend repair broken glass and re-seal all windows. 2 metal doors: single door on east side is rusted; advise replacement. Double metal door with one lite on south side is in **fair condition** - this door has panic hardware, but the metal threshold needs to be replaced. Transom is boarded up; recommend repair and repaint. Wall unit a/c in north wall is rusted.

Wood window and door trim are in **poor condition**; replacement of +/- 20 LF recommended. Repair and repaint all. Wood fascia is in **fair condition**. Metal drip edge at foundation is rusted.

Poured concrete slab built up on CMU wall in NW corner is in **fair/ poor condition**. Cracks in NW corner of foundation - recommend repair and repoint 100%.
